# Aviation Investigation Preliminary Report

<b>Location:</b>	Portland, OR	<b>Accident Number:</b>	DCA24MA063
<b>Date &amp; Time:</b>	January 5, 2024, 17:14 Local	<b>Registration:</b>	N704AL
<b>Aircraft:</b>	Boeing 737-9	<b>Injuries:</b>	177 None
<b>Flight Conducted Under:</b>	Part 121: Air carrier - Scheduled

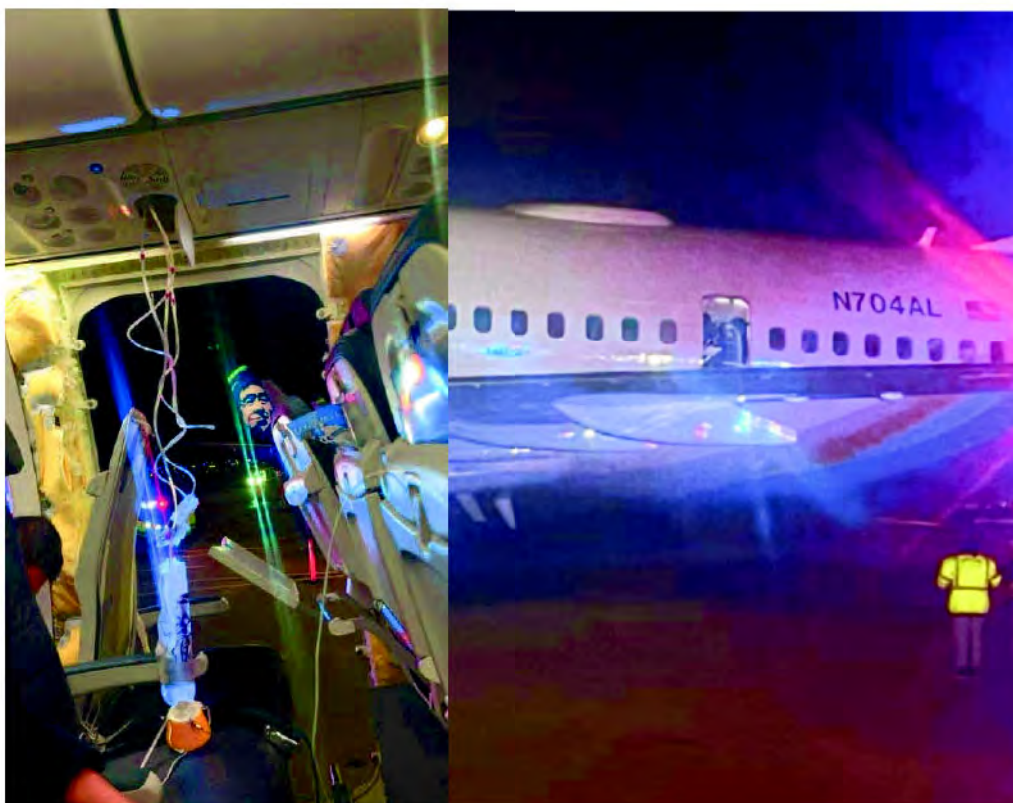
Figure 1 below shows the location of the missing MED plug from inside and outside the airplane. The separation of the MED plug from the airplane adversely affected the pressurization performance of the airplane and the damage to the MED plug adversely affected its structural strength, requiring replacement of the MED plug, resulting in a classification of substantial damage in accordance with Title 49 *CFR* Part 830.

**Figure 1.** Photos of the location of the missing MED plug. (Source: left photo provided by a passenger. Right photo provided by media.)

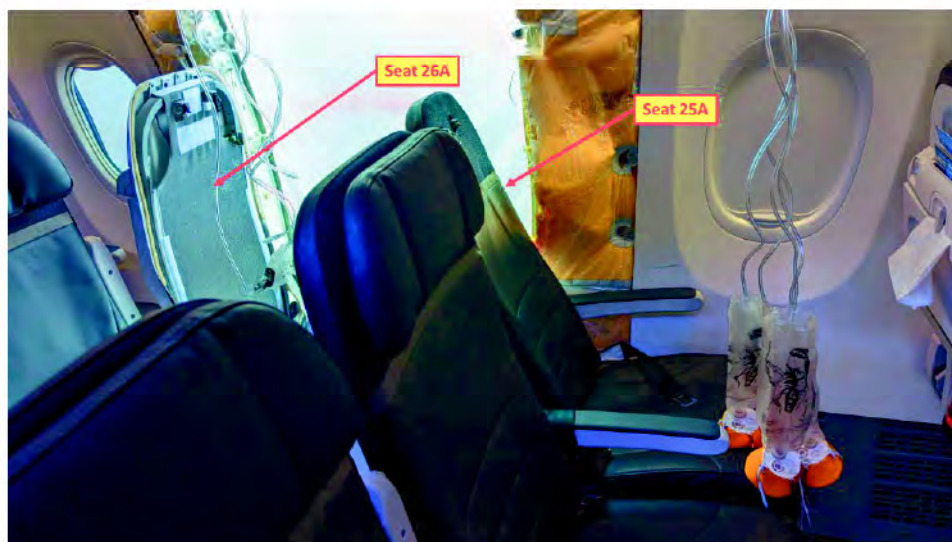
Damage to the passenger cabin included: damage in seat rows 25ABC and 26ABC as described below, deformation of the doorframe of the forward lavatory, and buckling and displacement of the sidewall panels and trim throughout the airplane. There were no indications of any other failures or malfunction of the airplane or any of its systems.

As seen in figure 7, Seat 25A was rotated out and aft approximately 10°–20° toward the opening. The seatback of Seat 26A was rotated forward and outboard.

**Figure 7.** Photo of seat rows 25ABC and 26ABC.

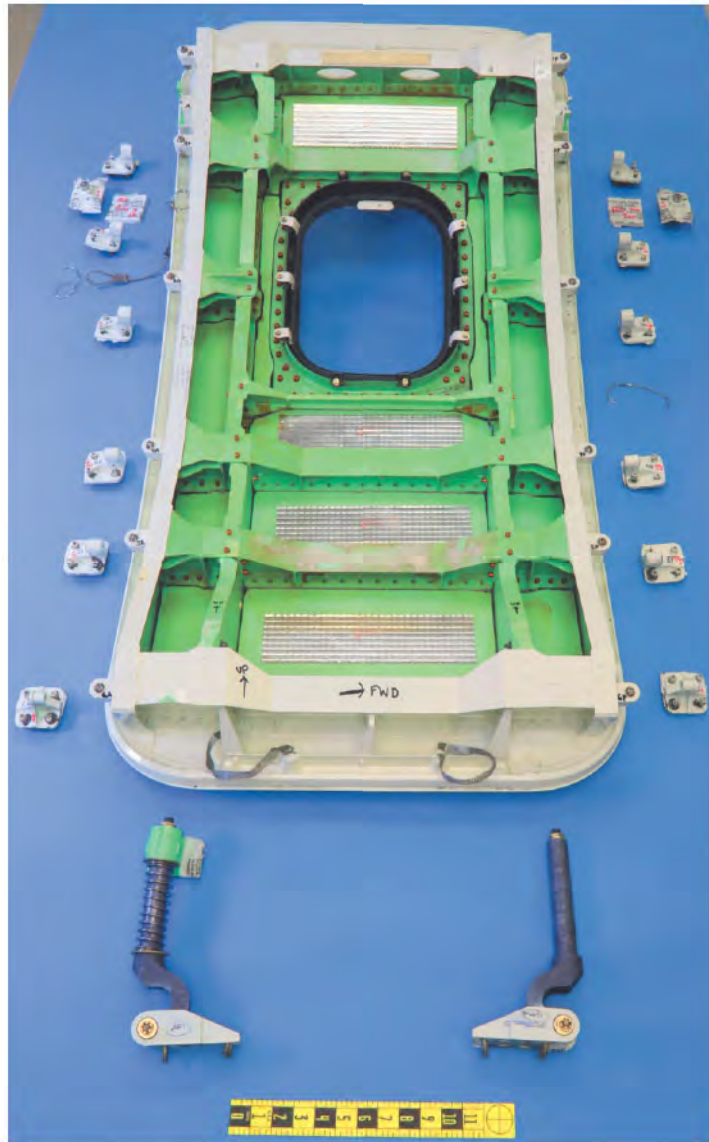
The NTSB Structures and Materials specialists, along with representatives from parties to the investigation, examined the MED plug and associated components removed from the accident airplane shown in figure 8 as received in the NTSB Materials Laboratory. The MED plug was mostly intact with some damage from the event and appeared to be manufactured in accordance with the engineering drawings.

**Figure 8.** Overall view of the MED plug and associated components removed from the accident airplane as received at the NTSB Materials Laboratory.

The two vertical movement arrestor bolts, two upper guide track bolts, forward lower hinge guide fitting, and forward lift assist spring were missing and have not been recovered. See figure 5 for example of installed locations.

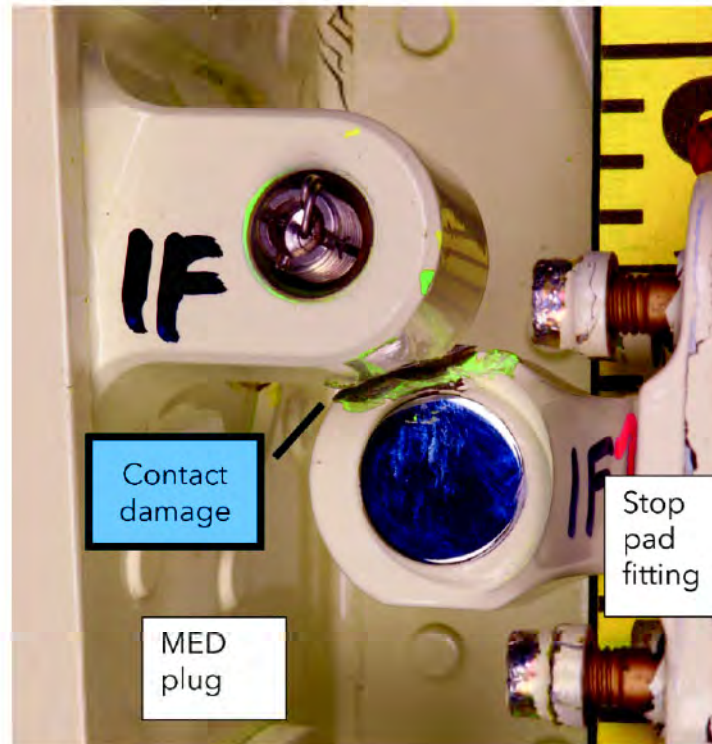
Contact damage was noted on the lower sides of the 12 stop pins and fittings on the MED plug. Corresponding contact damage was noted on the 12 stop pads and fittings attached to the fuselage. Overall, the damage was consistent with the MED plug translating upward, outboard, and aft during the separation. Figure 9 shows damage features at the upper forward stop location and is representative of the other stop locations.

**Figure 9.** Witness mark matching between upper forward MED plug stop pin fitting and stop pad fitting as received in the NTSB Materials Laboratory.

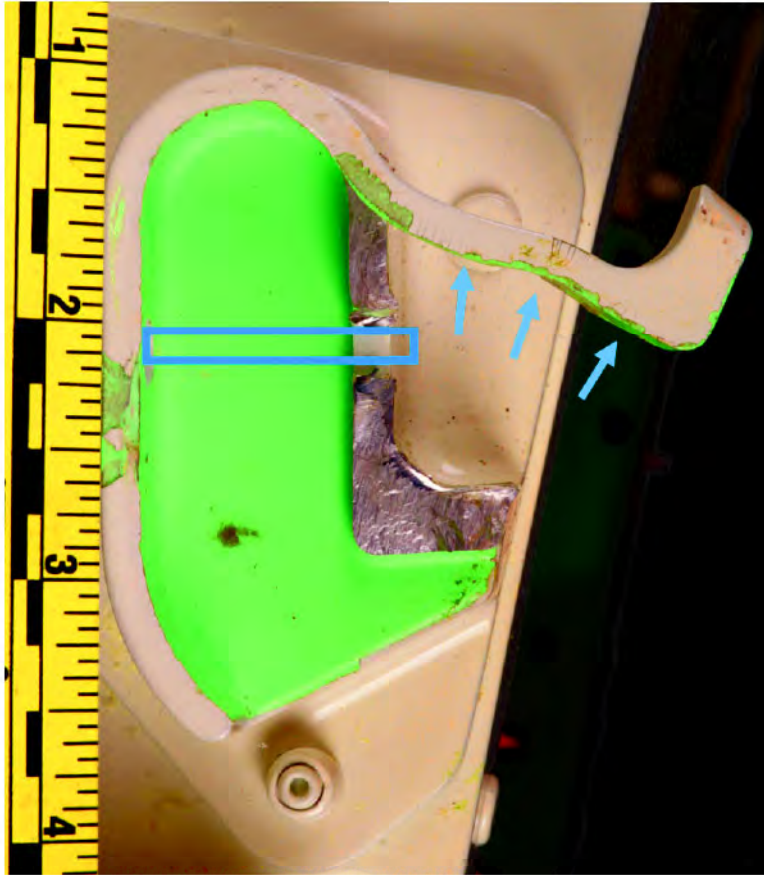
Both upper guide fittings installed on the forward and aft sides of the MED plug, respectively, were fractured vertically through the inboard wall of the track. Examination revealed features consistent with overstress fracture and no evidence of pre-existing cracks or damage. The outboard upper guide track bolt holes were intact and exhibited no deformation. Figure 10 shows the aft upper guide fitting; the forward upper guide fitting was similar.

**Figure 10.** Fractured aft upper guide fitting. Arrows point to the fractured and deformed piece of the guide fitting's inboard wall. The rectangle indicates where the upper guide track bolt would be installed.

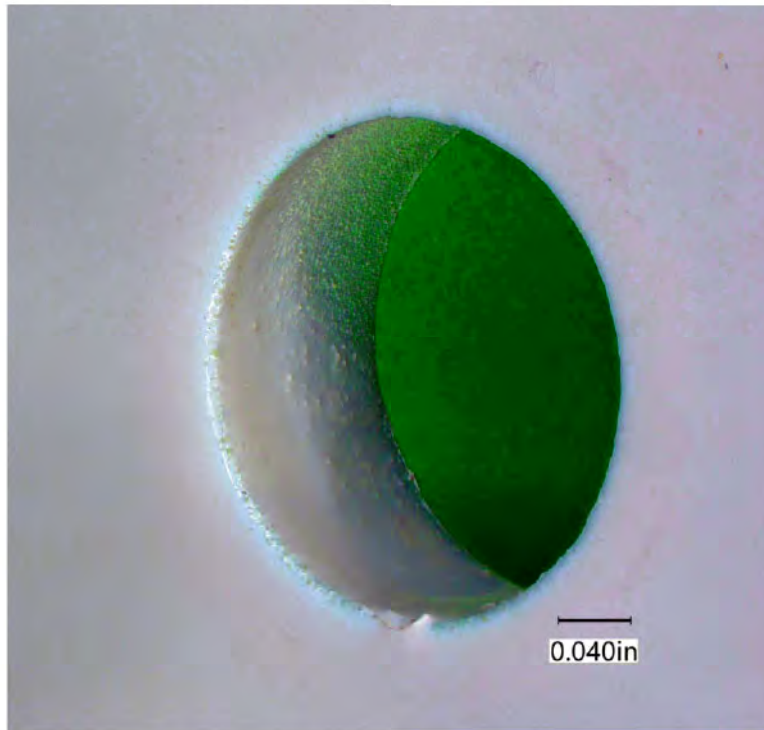
The paint in the upper guide track bolt hole bores was intact and showed no evidence of heavy contact damage. Figure 11 shows a representative hole bore. There were some light circular witness marks around the hole bores consistent with the presence of a washer at some time.

**Figure 11.** Aft upper guide track fitting showing the outboard track bolt hole bore.

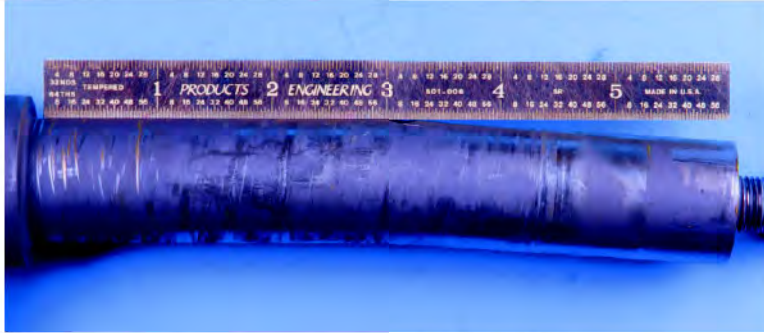
The aft hinge fitting was bent inboard about  $3.7^\circ$  with corresponding contact damage noted to the MED plug lower beam. Contact damage was noted on the inboard side of the hinge fitting shaft intersecting the vertical movement arrestor bolt hole consistent with contact with the MED plug, but the hole bore was otherwise undamaged. The outboard side of the vertical movement arrestor bolt hole was slightly elongated and exhibited small tensile cracks at the apex of the bend consistent with plastic deformation of the hinge fitting shaft (figure 12). The hole bore was otherwise undamaged.

**Figure 12.** Aft hinge fitting after disassembly showing the bent shaft.

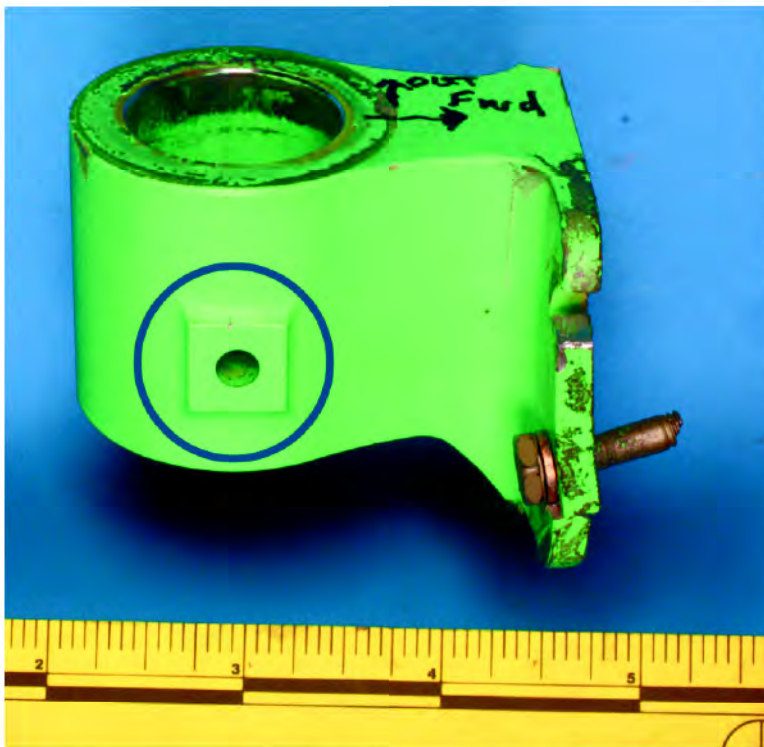
The attachment flange on the aft lower hinge guide fitting was fractured at the two upper attach hole locations, and the bolts remained installed in the MED plug. The two lower attach bolts were fractured. A similar damage pattern was noted on the MED plug at the forward lower hinge guide fitting attachment location. All features were consistent with ductile overstress fracture. The vertical movement arrestor bolt holes in the aft lower hinge guide fitting were intact and undamaged (figure 13).

**Figure 13.** Aft lower hinge guide fitting after disassembly. Circle shows the location of the vertical movement arrestor bolt hole.

Overall, the observed damage patterns and absence of contact damage or deformation around holes associated with the vertical movement arrestor bolts and upper guide track bolts in the upper guide fittings, hinge fittings, and recovered aft lower hinge guide fitting indicate that the

four bolts that prevent upward movement of the MED plug were missing before the MED plug moved upward off the stop pads.

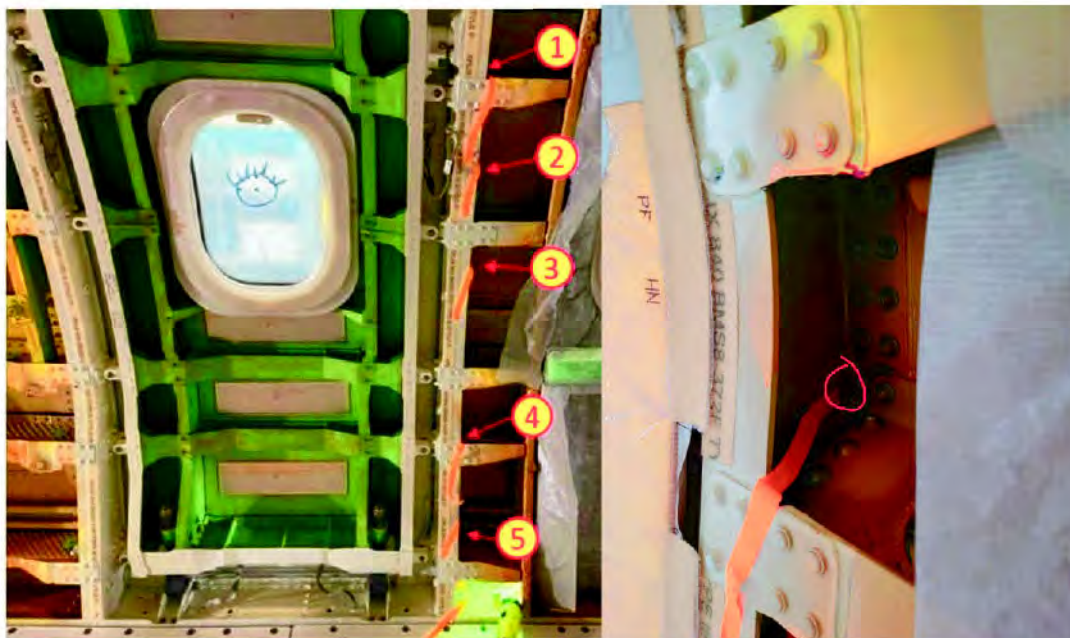
On September 1, 2023, records show that NCR 1450292531 was created noting five damaged rivets on the edge frame forward of the left MED plug. See figure 14 for rivet locations.

**Figure 14.** Photo on the left shows the five locations of the damaged rivets. Photo on the right is a close-up of a damaged rivet. (Source: Boeing. Image Copyright © Boeing. Reproduced with permission.)

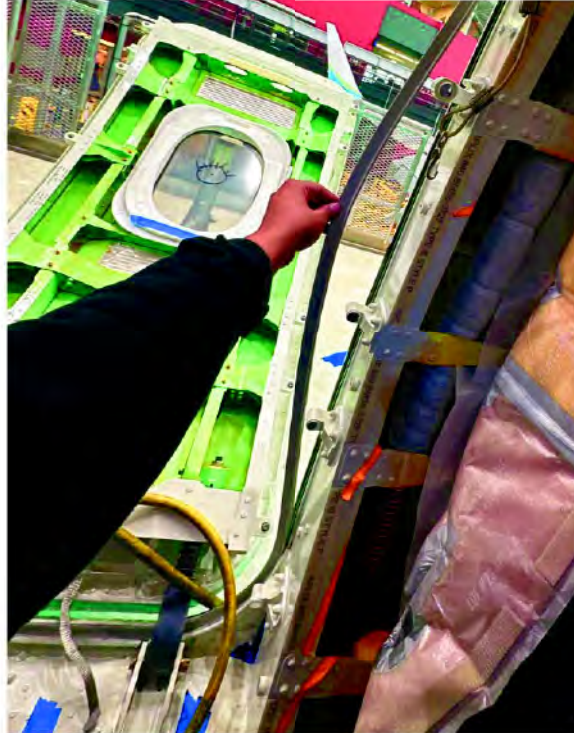
Documents and photos show that to perform the replacement of the damaged rivets, access to the rivets required opening the left MED plug (see figure 15). To open the MED plug, the two vertical movement arrestor bolts and two upper guide track bolts had to be removed.

**Figure 15.** Photo showing the MED plug opened to work on damaged rivets. (Source: Spirit AeroSystems.)

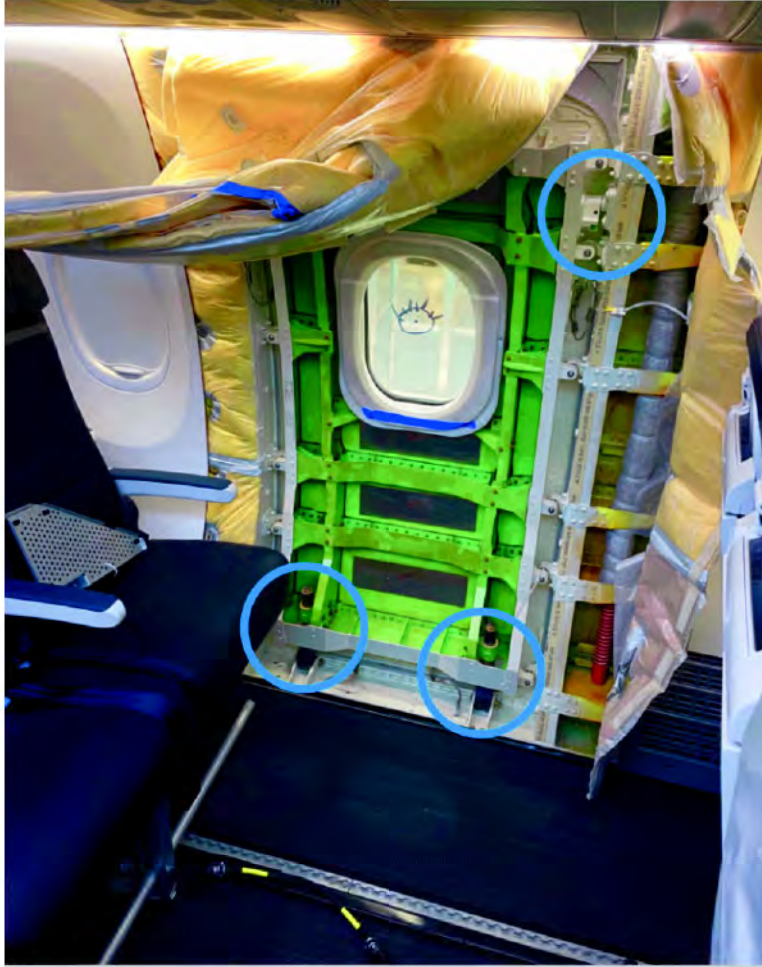
Records show the rivets were replaced per engineering requirements on Non-Conformance (NC) Order 145-8987-RSHK-1296-002NC completed on September 19, 2023, by Spirit AeroSystems personnel. Photo documentation obtained from Boeing shows evidence of the left-hand MED plug closed with no retention hardware (bolts) in the three visible locations (the aft upper guide track is covered with insulation and cannot be seen in the photo). See figure 16. This image was attached to a text message between Boeing team members on September 19, 2023, around 1839 local. These Boeing personnel were discussing interior restoration after the rivet rework was completed during second shift operations that day.

**Figure 16.** Photo showing the left MED plug immediately before interior restoration and the circles show the three locations without the retaining bolts, two vertical movement arrestor bolts and the forward upper guide track bolt. The aft upper guide track is covered with insulation and cannot be seen in the photo. (Source: Boeing. Image Copyright © Boeing. Reproduced with permission.)
