# Aviation Investigation Preliminary Report

<b>Location:</b>	Portland, OR	<b>Accident Number:</b>	DCA24MA063
<b>Date &amp; Time:</b>	January 5, 2024, 17:14 Local	<b>Registration:</b>	N704AL
<b>Aircraft:</b>	Boeing 737-9	<b>Injuries:</b>	177 None
<b>Flight Conducted Under:</b>	Part 121: Air carrier - Scheduled

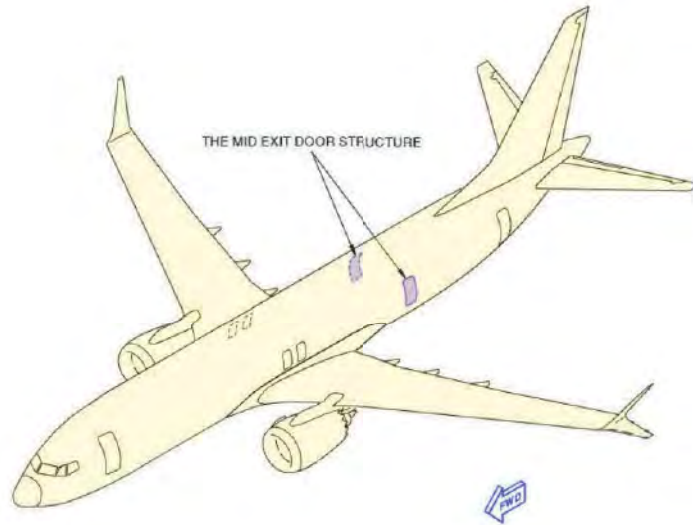
Mid Exit Door Structure Location

The airplane was equipped with a MED plug option (see figure 2 and third image in figure 3 below), which Alaska Airlines had selected based on its desired seating configuration. Benefits afforded by the plug option include:

**Figure 2.** Diagram showing the mid exit door locations. (Source: Boeing. Image Copyright © Boeing. Reproduced with permission.)

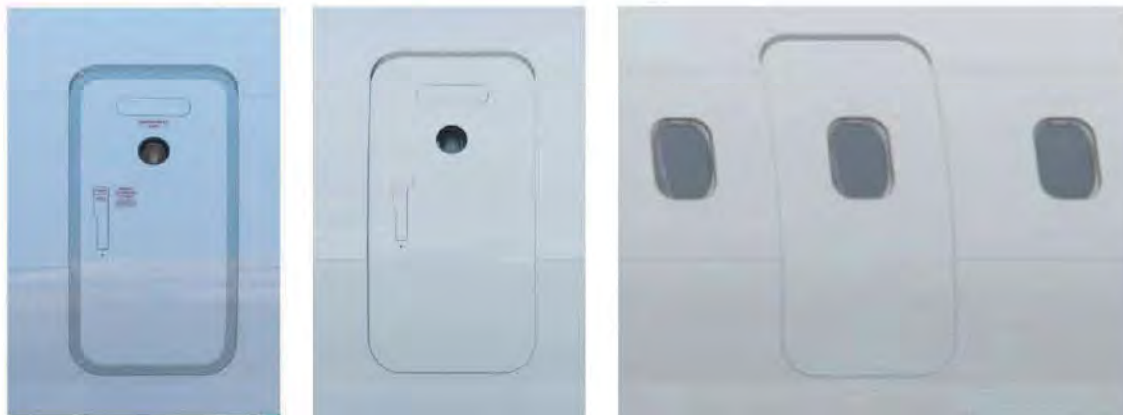
**Figure 3.** Three types of mid exit doors. (Source: Boeing. Image Copyright © Boeing. Reproduced with permission.)

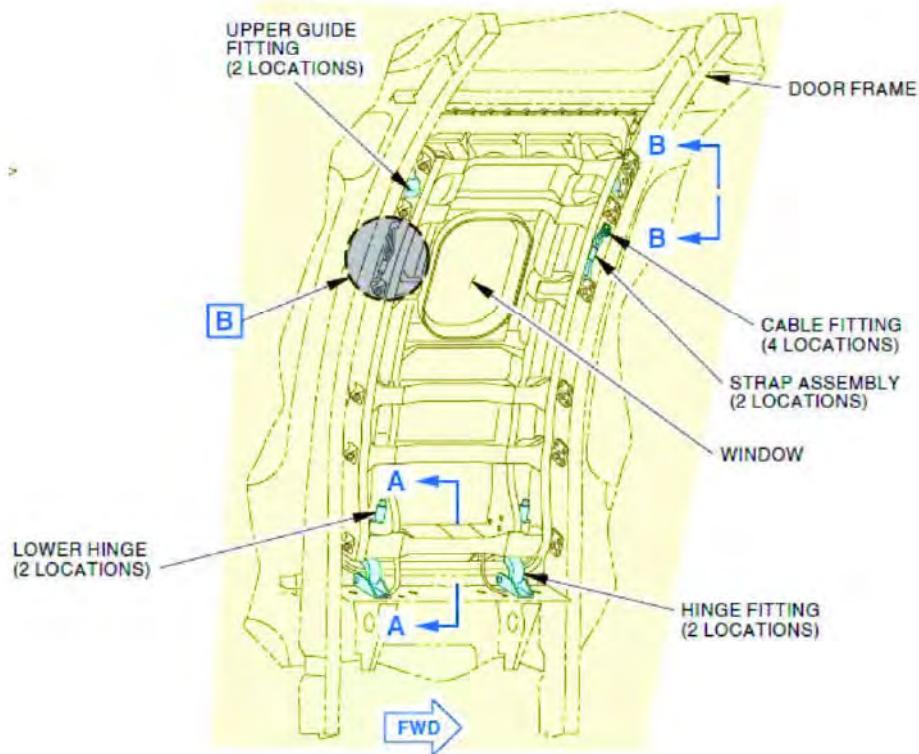
The MED plug is primarily constructed of aluminum and is installed in the fuselage by means of two upper guide fittings and two lower hinge fittings (see figures 4 and 5). The two upper guide fittings are located on the upper sides of the plug and engage with two upper guide rollers that are fixed to the upper sides of the fuselage opening (see figure 6). Two lower hinge guide fittings are fixed to the lower section of the plug and engage with the two lower hinge fittings that are attached to the bottom of the fuselage opening at the lower hinge bracket assemblies.

**Figure 4.** 737-9 Mid Exit Door Plug. (Source: Boeing. Image Copyright © Boeing. Reproduced with permission.)

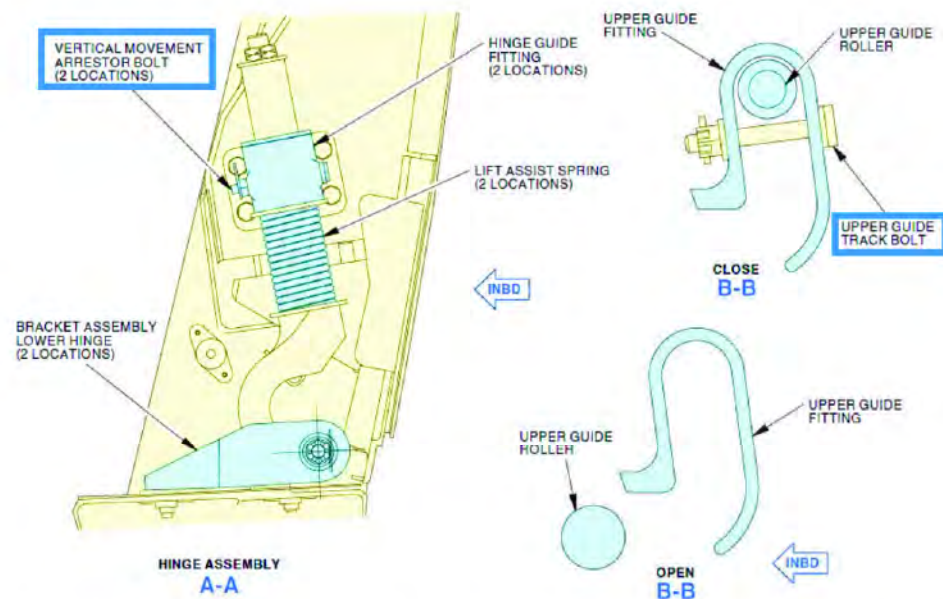
Once the plug is in place, it is secured from moving vertically by a total of four bolts. There is a bolt installed through each upper guide fitting and each lower hinge guide fitting. Once these bolts are installed, they are secured using castle nuts and cotter pins. Outboard motion of the plug is prevented by 12 stop fittings (6 along each forward and aft edge) installed on the fuselage door frame structure.

**Figure 5.** 737-9 Mid Exit Door Plug – Arrestor and Track Bolts. Boxes added for emphasis. (Source: Boeing. Image Copyright © Boeing. Reproduced with permission.)

The two vertical movement arrestor bolts, two upper guide track bolts, forward lower hinge guide fitting, and forward lift assist spring were missing and have not been recovered. See figure 5 for example of installed locations.

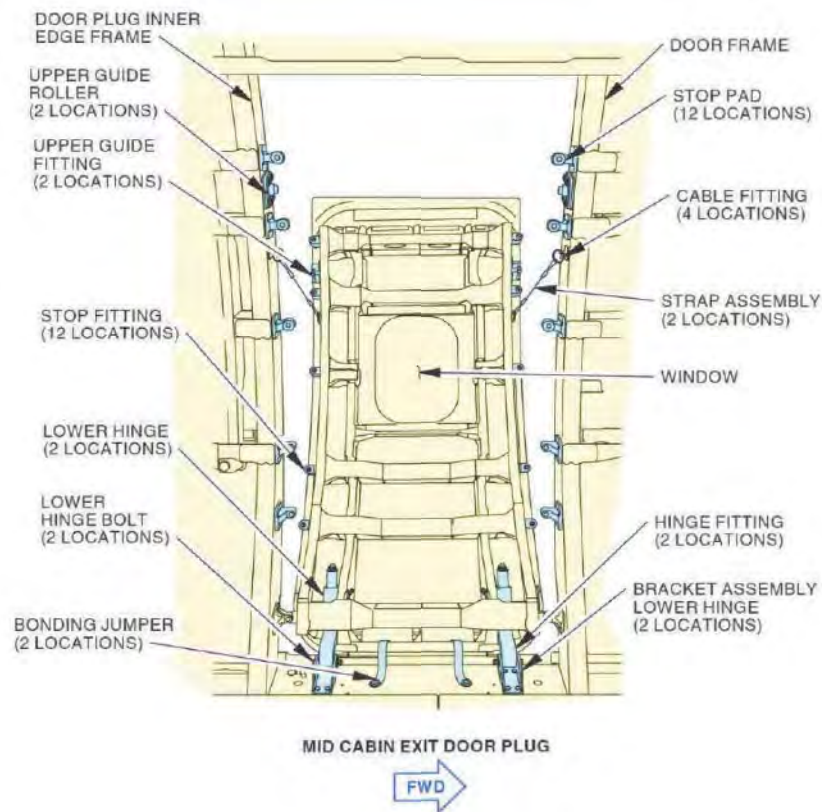
The door plug is only intended to be opened for maintenance and inspection, which requires removing the vertical movement arrestor bolts and upper guide track bolts. The strap assemblies below the second stop pad from the top restrict the plug from opening further than 15°, suitable for maintenance and inspection purposes (see figure 6).

**Figure 6.** 737-9 Mid Exit Door Plug – Components. (Source: Boeing. Image Copyright © Boeing. Reproduced with permission.)
